Bulletin 3/2007

# MADHUBAN MEADOWS

*Diagnosis and Amelioration of Alkali Soils in Golf Course  
at The Haryana Armed Police Madhuban, Karnal- Haryana*

CENTRAL SOIL SALINITY RESEARCH INSTITUTE KARNAL, HARYANA,  
I.C.A.R  
AND  
HARYANA ARMED POLICE, MADHUBAN, KARNAL,

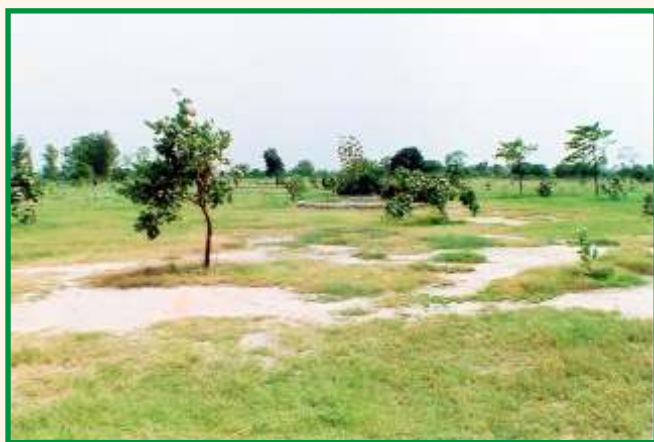
Plate.1. Alkali patches in the golf course at HAP Madhuban

But, appearance of several bald and barren patches measuring 5 to 80 square meters marred the beauty of the green turf (Plate 1). Similarly some raised beds and sunken channels also suffered with poor and stunted plant growth. A detailed investigation of soil, land and

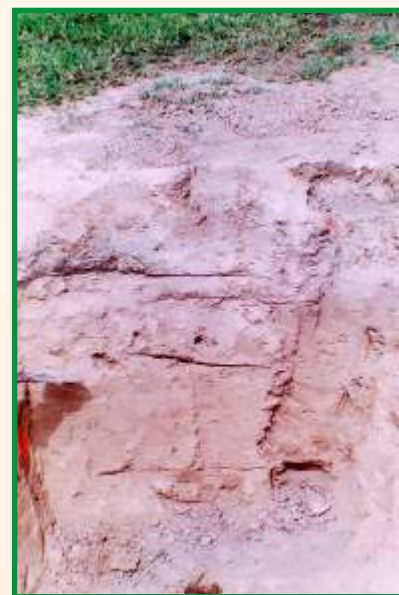
Plate.2. Hard and compact alkali soil profile at HAP Madhuban

The golf course was traversed and representative patches were selected for study. The soils were sampled upto 4 feet depth for laboratory analysis. The soil layers in barren patches were found very dry, hard, and dense, devoid of soil pores (Plate 2). Plentiful lime nodules were also present in the soil, which is a common feature found in alkali soils of Haryana. Layer wise morphology of a typical soil profile representing alkali soils existing in northern India is described in the later part of the bulletin. Ground water sample from installed tube well was also collected and analysed to ascertain the quality of irrigation water.

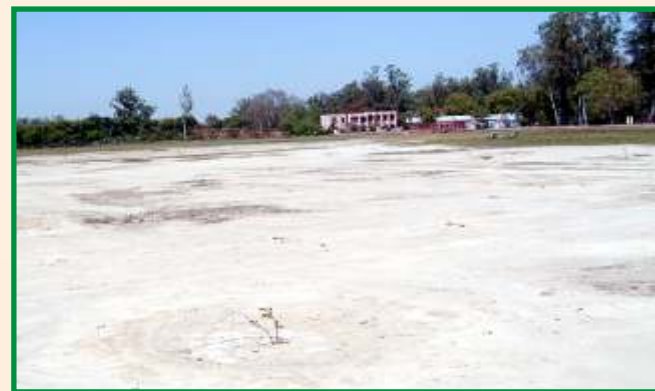
Plate 3. Strong alkali soils in cricket ground

Besides the golf course, some other sites like the cricket ground, rose garden and areas around the stadium are also affected by severe alkali hazard. A large area of the cricket ground is covered under strong alkali soils, while the rose garden occupies strong alkali in patches (Plate 3). Characterized by extremely hard and infertile surfaces the strong alkali soils have either turned into barren lands or grown some coarse grasses or stunted trees. Soil characteristics (Table 3) indicate the severity of alkalinity in the cricket ground. These soils are amenable and can be treated with gypsum to bring substantial improvements in the playground. Moreover, some of the alkali characteristics can be beneficially utilized in preparing fast and bouncy cricket pitches,

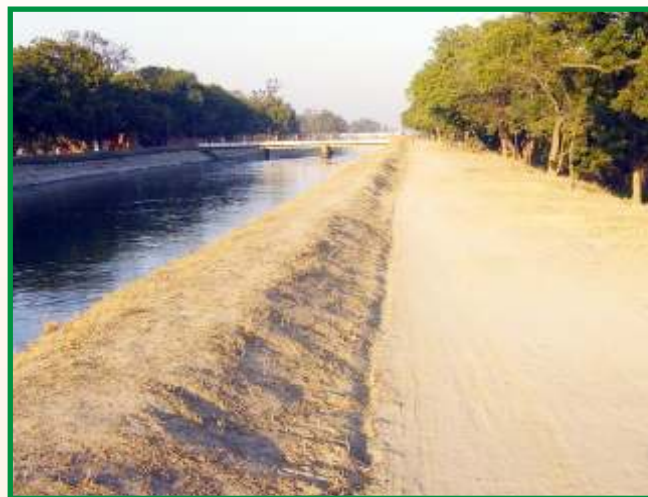
Plate 4. Canal embankments could be developed as water- front parks

proceeding pages. Another notable feature is the running of augmentation canal through the HAP Madhuban (Plate 4). About 1.5 km long canal embankments offer good scope for soil and water conservation measures. It can be developed into a beautiful waterfront-park by carving the slopes into small steps and terraces and planting with flowerbeds and herbs to serve as a recreation spot both for the children and the elders. Installation of fancy lights and

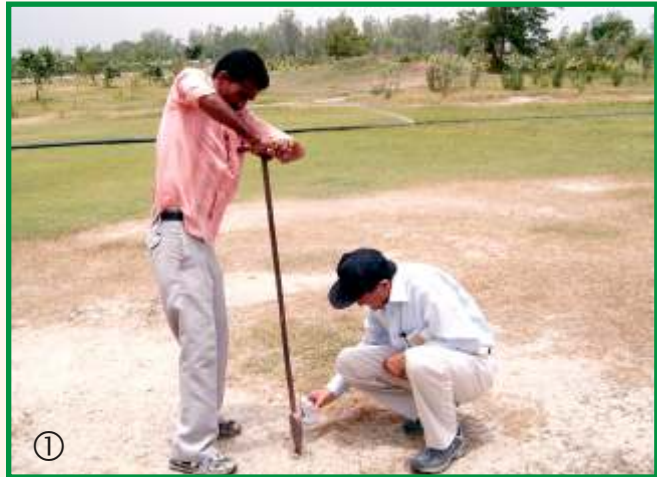
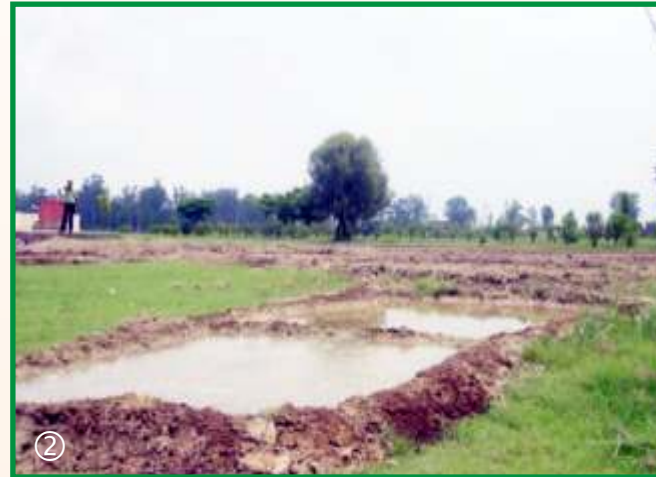
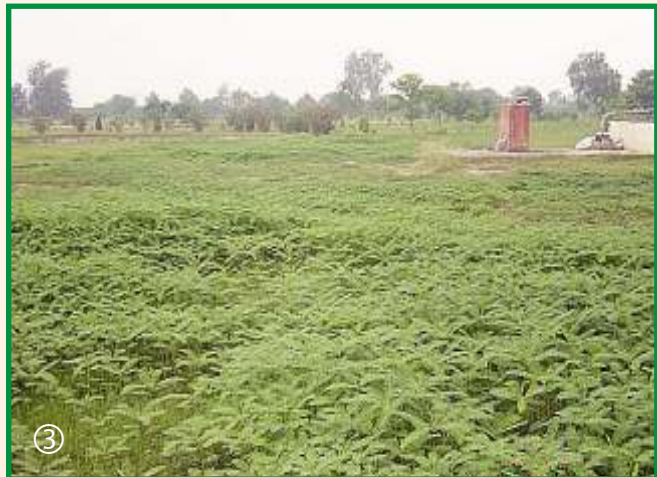
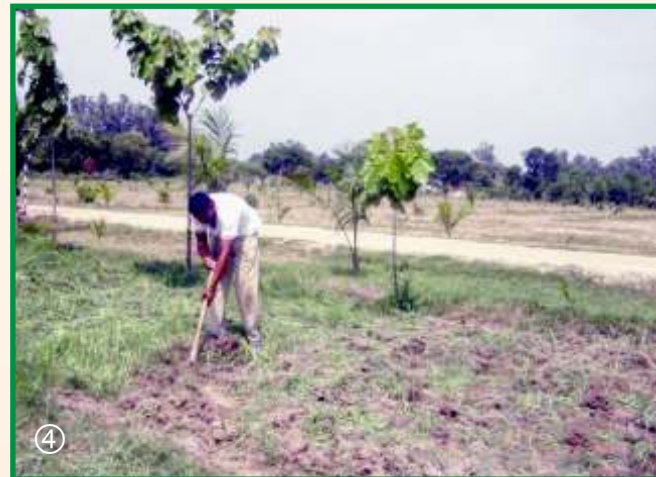
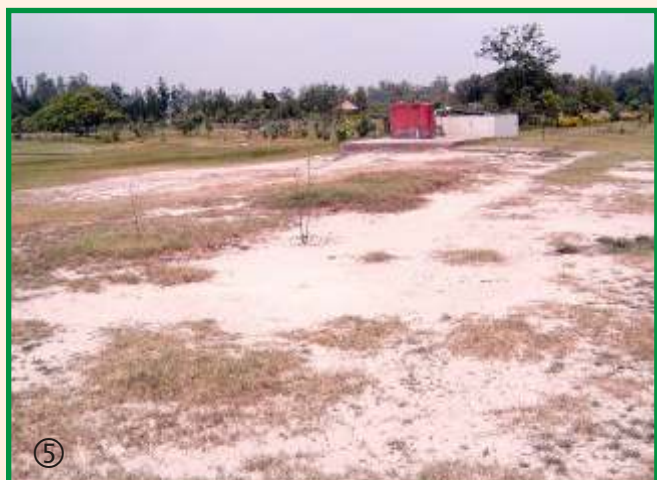
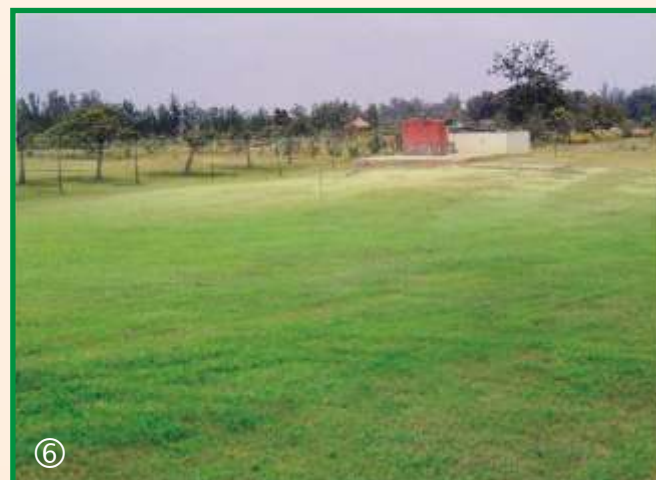
Plate 5. Steps in alkali soils reclamation

The golf course is interspersed with several patches of moderate to strong alkali soils. The methods and practices adopted to reclaim these patches are briefly described below and progressive reclamation is shown in plate 5.

After proper leveling, strong bunds around each alkali patch were made and irrigated heavily. After the soil attained workable soil moisture condition, gypsum @ 17-20 t/ha was uniformly sprinkled and mixed with a spade upto a depth of 12-14 cm. Recommended dose of Dermit insecticide was applied to free the soil of

commonly occurring insects. The patches were again irrigated and broadcasted with *dhaincha* seed @ 75 kg/ha and a soft dose of urea @ 50 kg N/ha was applied. Addition of Zinc Sulphate @ 20kg /ha hastened the reclamation process. The soil was kept wet with frequent irrigations. *Dhaincha* plants were cut after attaining a height of 30-35 cm, buried in the soil and allowed to decompose. The soil was flooded with water till *dhaincha* was largely decomposed. The grass was planted and irrigated regularly to maintain sufficient wetness in the soil. After grass had been established, recommended doses of fertilizers and irrigation were

1. Diagnosis of alkali soils . 2. Leveling, bunding , gypsum application, irrigation and sowing of *dhaincha* in alkali soils
- 3.& 4. Burying *dhaincha* in soil. 5. Original alkali soil. 6.Reclaimed alkali soil
